RE: Wappinger Subaru Expansion- Stormwater Memo

Subaru is looking to construct an expansion on their existing showroom and service center located at 1162 Route 9 in the Town of Wappinger. In 2013 Prestige Mini received site plan approval for a 18,700 square foot sales and service center. A stormwater management plan was designed to treat impervious coverage associated with the approved design. Pervious pavement areas were used in line with pocket ponds to treat and attenuate stormwater on-site. Since the approval the property was consolidated with the lot to the north. Additional stormwater management practices were implemented to attenuate and treat stormwater associated with an additional parking expansion on property.

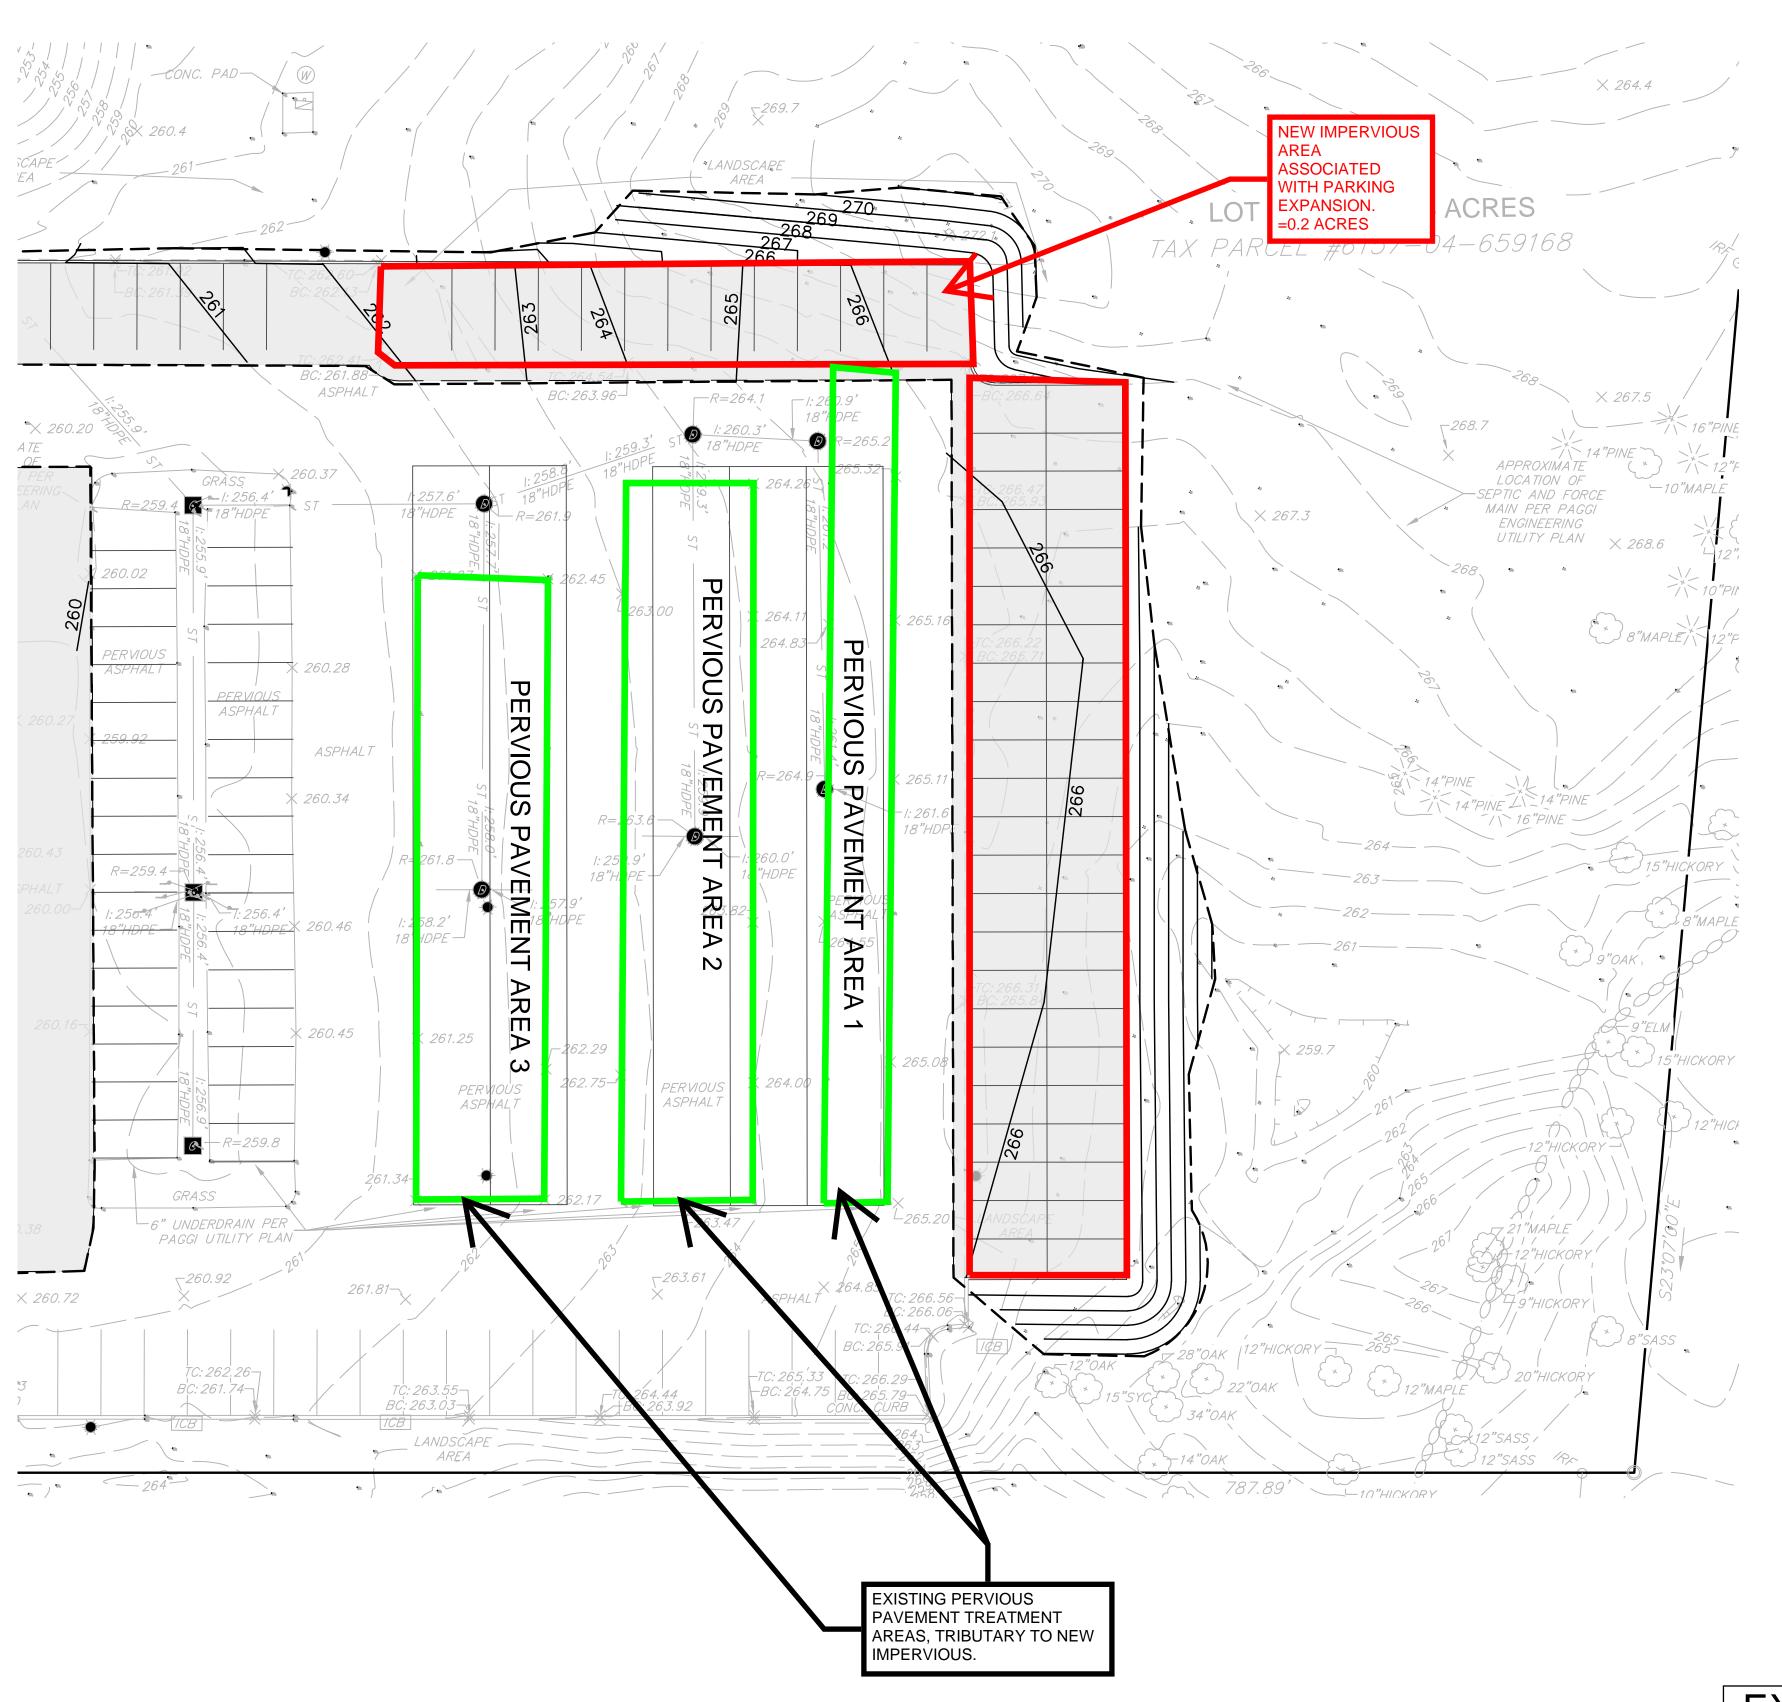
EXISTING PERVIOUS PAVEMENT AREAS SCALE: 1"=20'

The increase in impervious area on-site is directly related to the minimal expansion of parking area on the east and north sides of the existing site. These areas of slight impervious expansion have been designed to convey stormwater to existing pervious pavement treatment systems. Stormwater details associated with the 2013 design of the pervious pavement areas were obtained to understand the treatment capacity of the on-site pervious pavement areas. It was calculated the pervious pavement areas tributary of the new impervious were large enough to handle the additional impervious area associated with this expansion. Attached to this letter report are the stormwater details, water quality volume (Wqv), and map showing areas of new impervious to be treated.
